**BACKWARD COMPATIBILITY:  
PROTECTING THE PAST  
WITH FUTURE TECHNOLOGY**

**Presented at the THIC Meeting at the Hotel Villa, San Mateo, CA  
July 23, 1998**

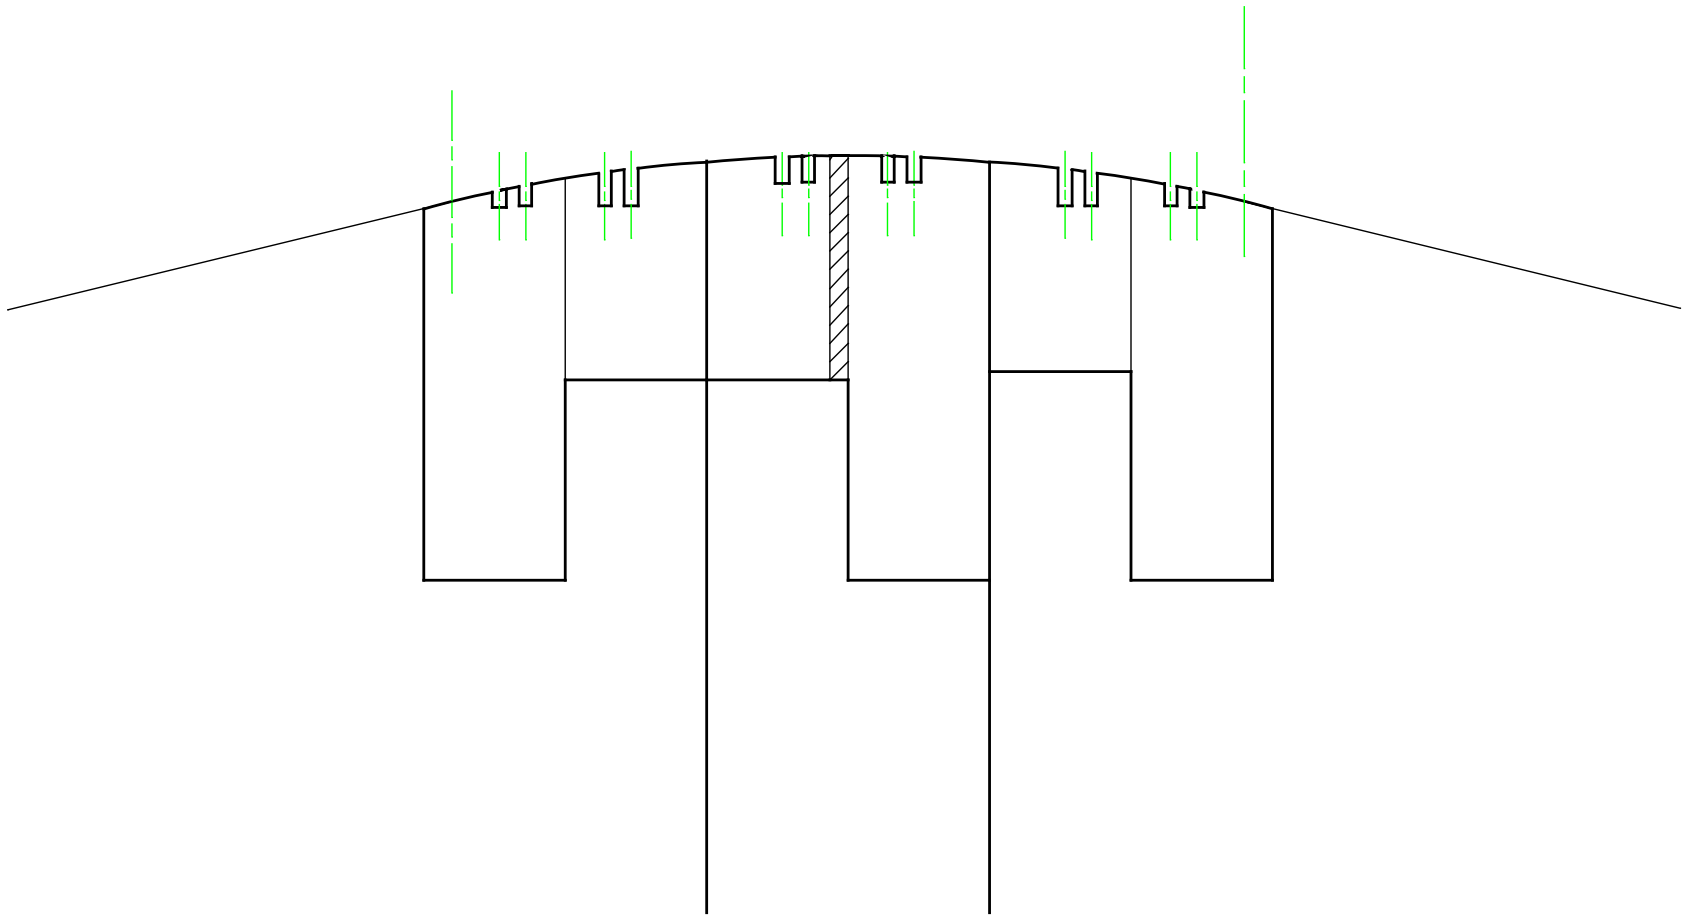
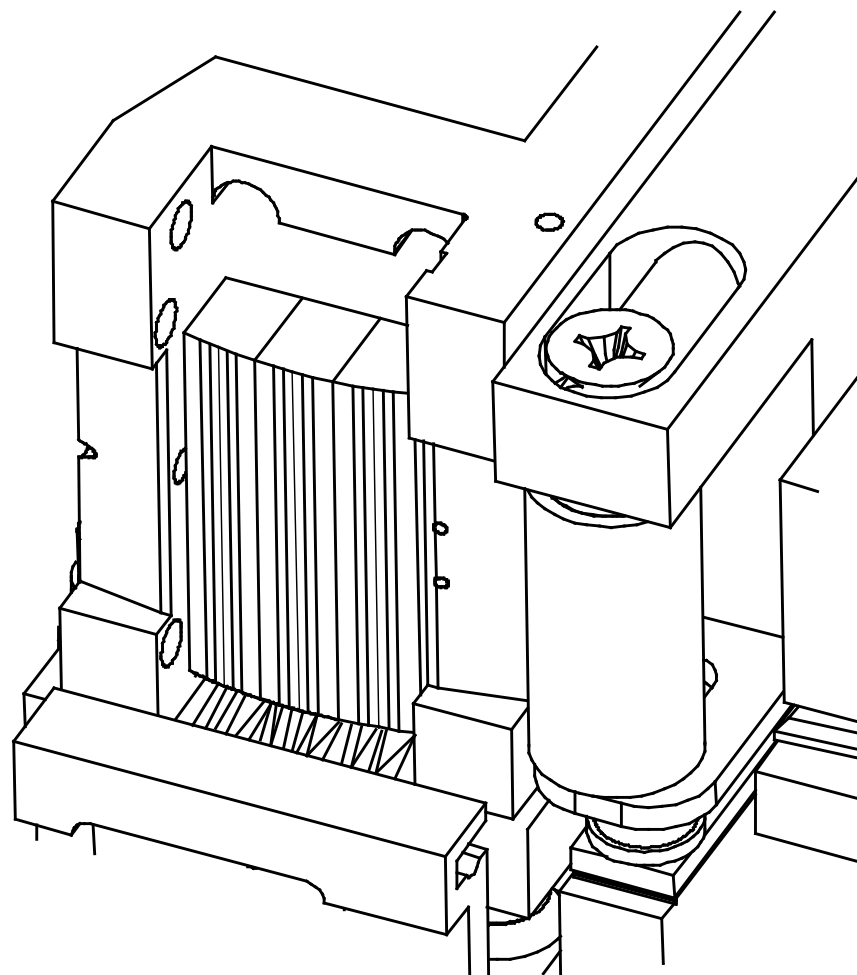
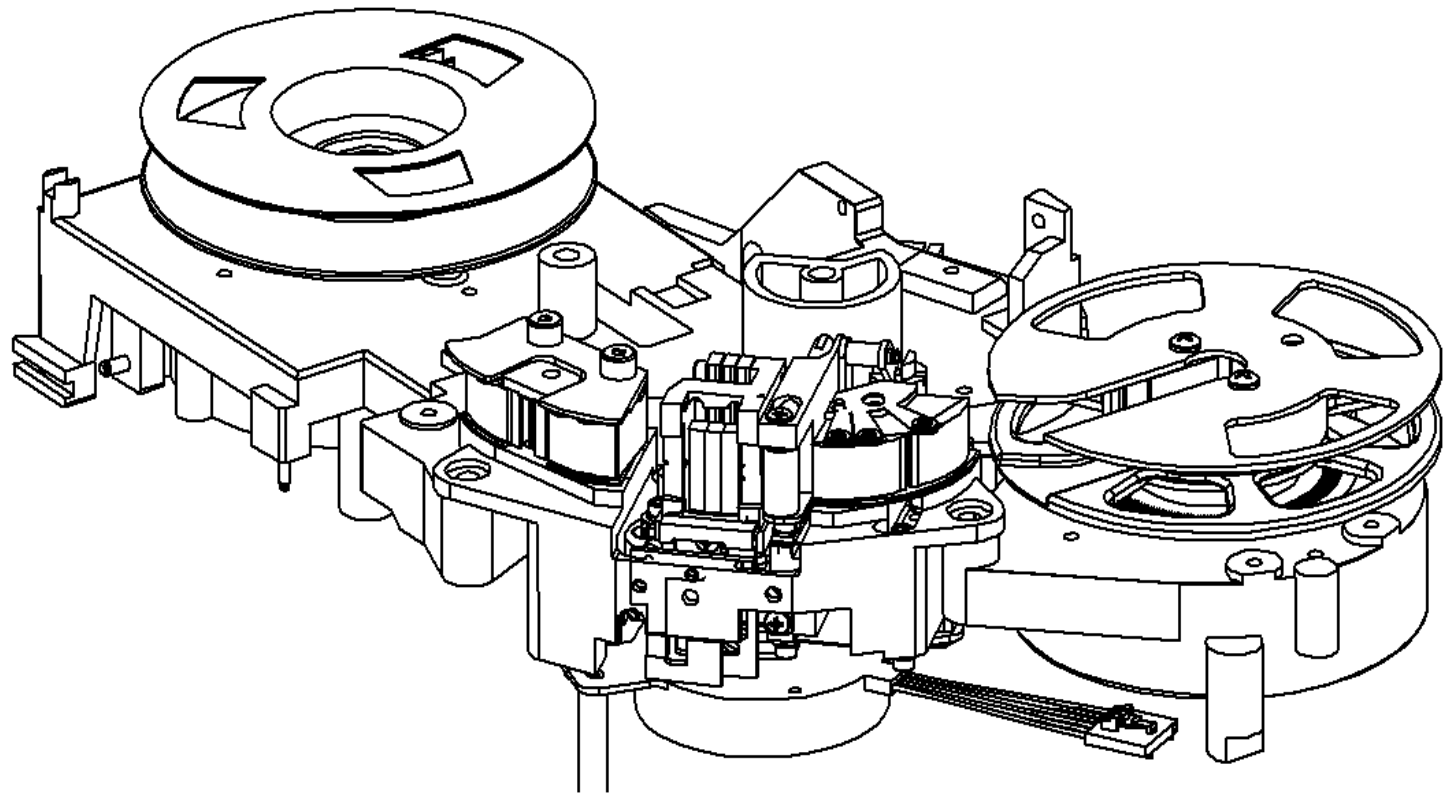
# **STICTION PROBLEM EXPERIMENTAL RESULTS**

- **START-STOP**
- **LESS VERTICAL SLOTS**
- **ALL FERRITE HEAD**

**STICTION** is caused by **DEGRADATION** of the  $\text{CrO}_2$  binder coating surface due to running start-stop over the **SHARP VERTICAL SLOT EDGES** of  $\text{AlTiC}$

- **SMALL CHAMFER** on the **SLOT EDGES**
- **USE MATERIALS SOFTER** than **AlTiC**
- **AVOID CrO<sub>2</sub> tapes TOUCHING** the **AlTiC WRITER**
